ROADBANK EROSION AND ITS CONTROL IN THE PIEDMONT UPLAND
OF GEORGIA

August 1963 ARS 41-73
Agricultural Research Service

UNITED STATES DEPARTMENT OF AGRICULTURE

E. G. Diseker, E. C. Richardson, and B. H. Hendrickson²

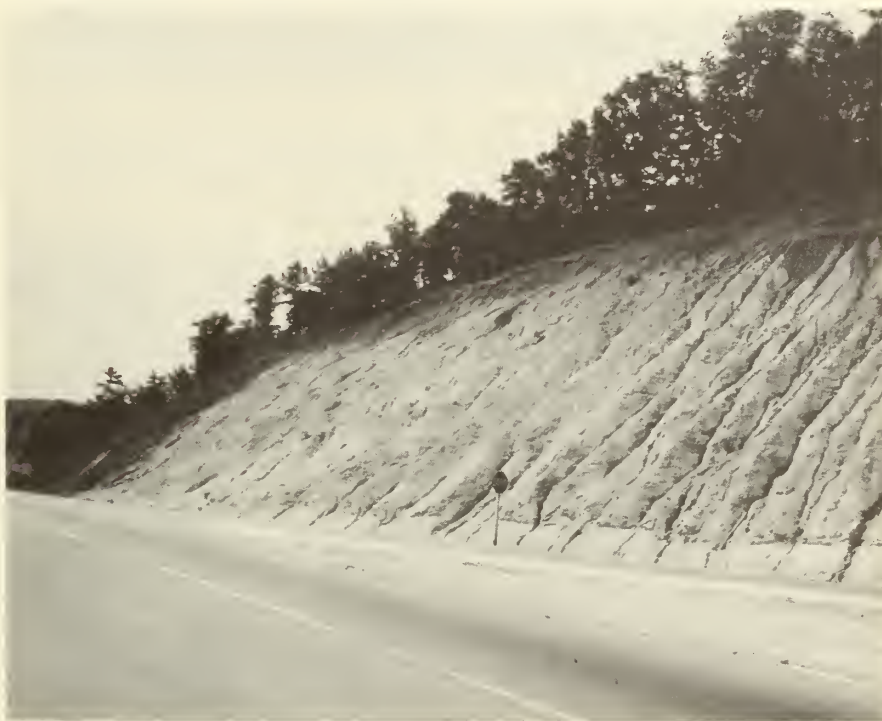
Figure 1.--A common sight on unprotected road cuts throughout the United States, particularly in the Southeast.

In the hilly Piedmont Upland section of northwestern Georgia, deep cuts through ridges, made during highway construction, expose areas of raw infertile subsoils on roadbank slopes that are highly susceptible to erosion (fig. 1). Runoff and soil-loss measurements made at

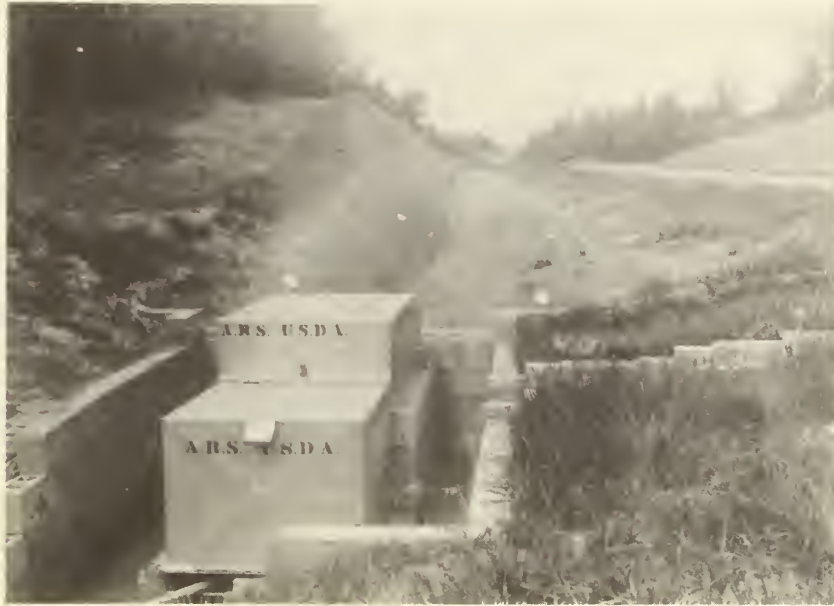
Figure 2.--View of a soil and water measuring device installed at the lower end of a plot ditch for measurement of losses occurring from highway cut slopes. The bare road cut and ditch are shown in the background where the white papers appear.

Six flumes, N-2 type Weir Coshocton soil and water samplers, and storage tank assemblies were designed and fabricated. When completed, these measuring and sampling units, each with masonry head, wing wall, and a 54-cu. ft. storage tank, were installed at the lower ends of the flow channels of each plot.

All runoff with soil suspension flowed through the 1-foot deep H-flume onto the Coshocton vane sampler. A 0.5-percent sample of the runoff was diverted to the storage tank located below the sampler (figs. 2, 3, and 4). A standard water-stage recorder with a stilling well was attached to the side of the flume and also was used to measure rate and volume of runoff. A nearby recording rain gage measured the amount and intensity of the rainfall at each set of plots.

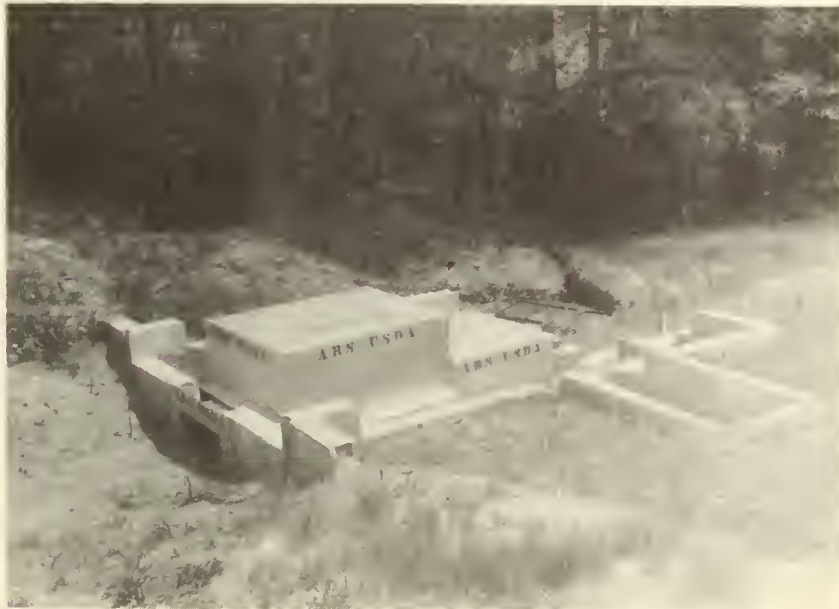
Figure 3.--An overall view of a soil and water measuring device in the lower end of the plot ditch. The black, covered, 54-cubic-foot storage tank is in the background where the 0.5-percent sample is collected.

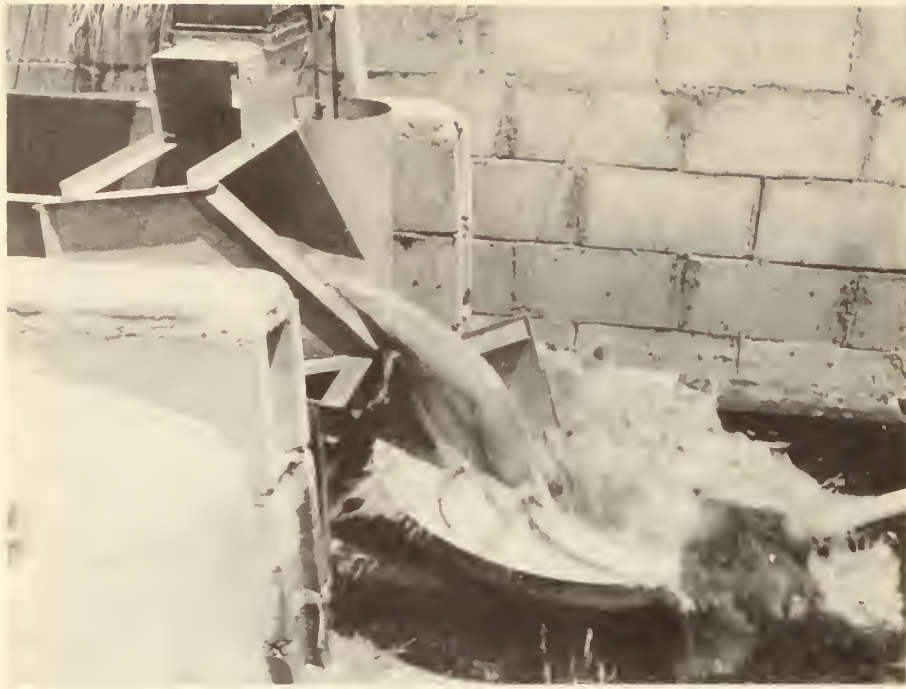
Figure 4.--Soil and water from the runoff plot has passed through the H-flume and is pouring onto the rotary Coshocton wheel, which is taking a sample of 0.5-percent of the runoff with suspended load. This fraction is diverted to the 54-cubic-foot storage tank below the measuring device.

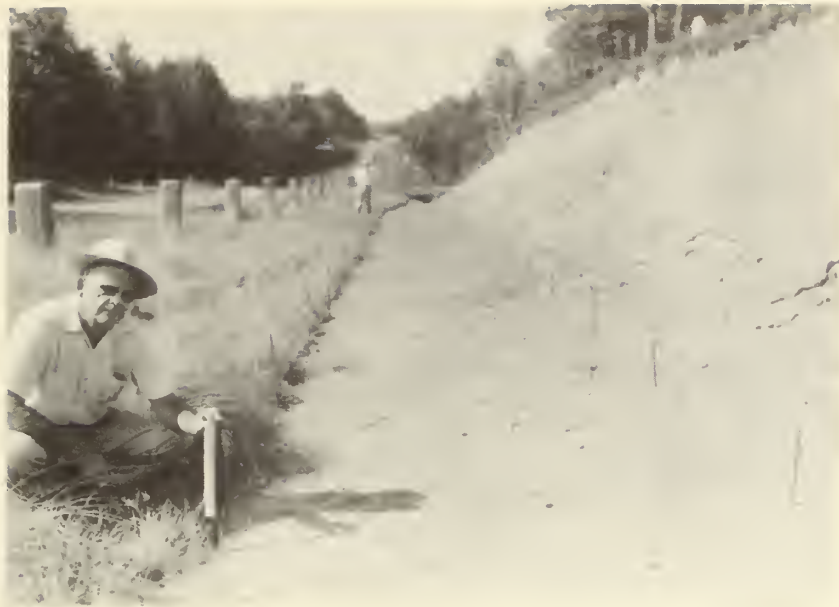
Figure 5.--Two rows of metal hub stakes spaced 6 by 6 feet are shown in the flow channel of a runoff plot. Annual measurements are made at 1-foot intervals around the squares of stakes and across the diagonals with equipment especially designed to determine the soil deposition or erosion that may have occurred in the flow channel.

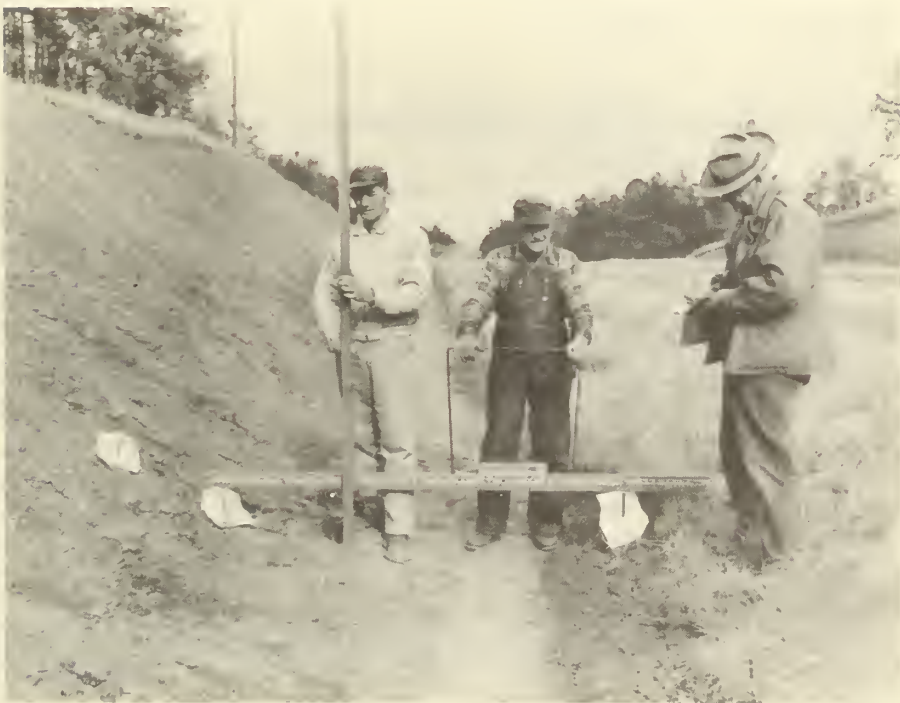
Figure 6.--The specially designed surveying equipment is being used in connection with metal hub stakes for measurement of erosion or sedimentation in the flow channel.

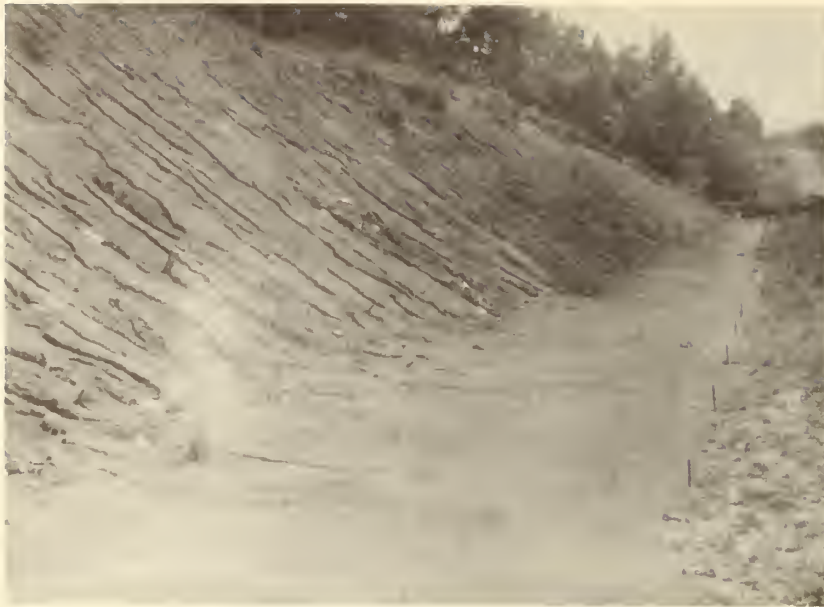
Figure 7.--Soil deposits were 8 inches deep in the upper end of the flow channel, as shown in the foreground of this photograph. The rilled effect of the bank surface was caused by runoff during one rain that followed severe frost action. Later, all the loose soil was washed from the bank, leaving it relatively smooth and firm.

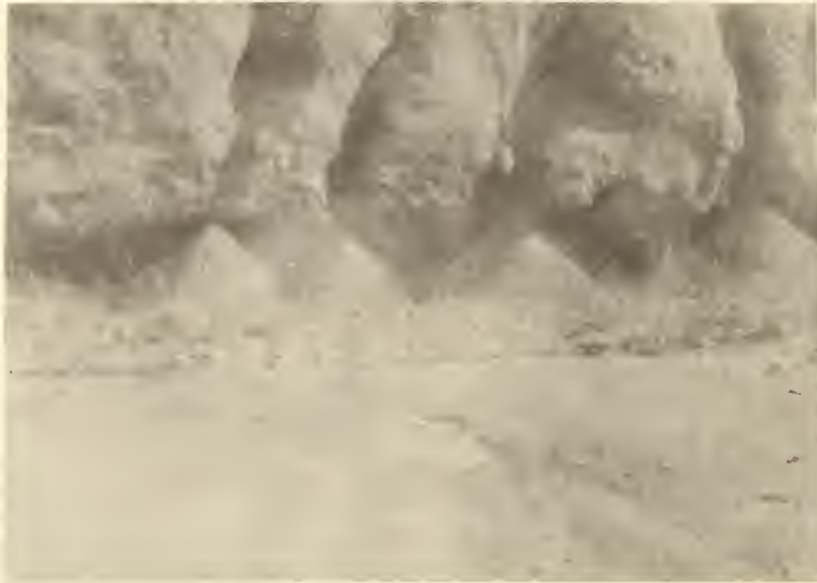
Figure 8.--The canes of loose soil are the result of freezing and thawing on a 1:1 Cecil clay unprotected roadbank facing north. The loose soil rolled down the bank into the ditch in a 2-day period after thawing.

Annual erosion losses for 1958 were high, particularly on the first four plots, because frost action was a major factor from December 1957 to February 1958 (figs. 8 and 9). The soil was

Roadbank orientation, or the direction the bare banks face, was a major factor in the erosion losses occurring on the six roadbank erosion plots (figs. 8 and 9). This was due to two reasons. First, it is known definitely that frost action contributes a major influence. Banks with a north to northwest aspect received less solar radiation and were more readily frozen than those facing east or southeast, and stayed frozen longer. Second, the bulk of precipitation in this area comes from a westerly direction; consequently, a bank facing west will receive a greater amount of raindrop impact than one facing in an easterly direction. During torrential storms, raindrop

Slope of bank has a marked effect upon erosion (fig. 8). Soil loosened by frost action does not roll down the 3:1 slope bank upon thawing, but remains in place unless runoff washes the loose soil from the banks. Runoff is probably also less on the gentler slopes because of better opportunity for infiltration than on the steep slopes.

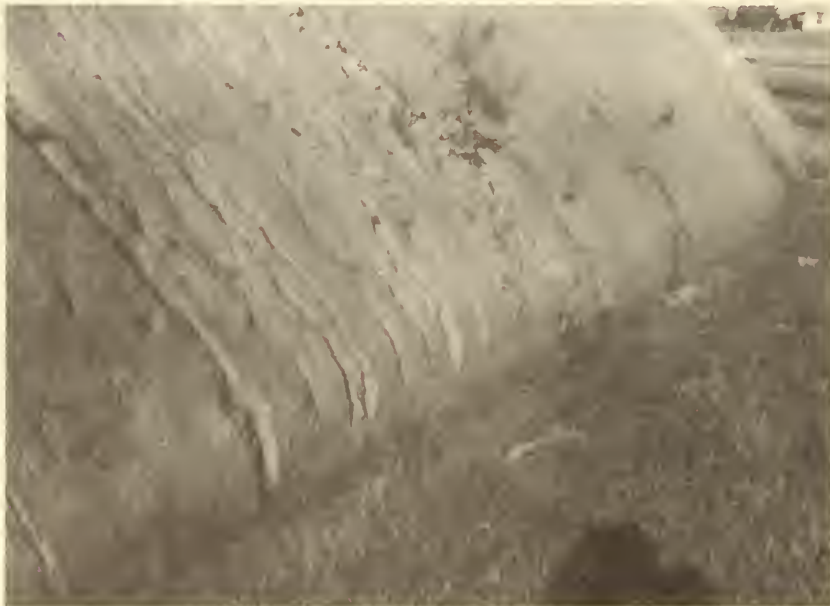
Figure 9.--This is the opposite bank facing the south just across a small road from the bank in figure 8. The bank in this figure had dried out and no freezing or erosion from frost action had occurred.

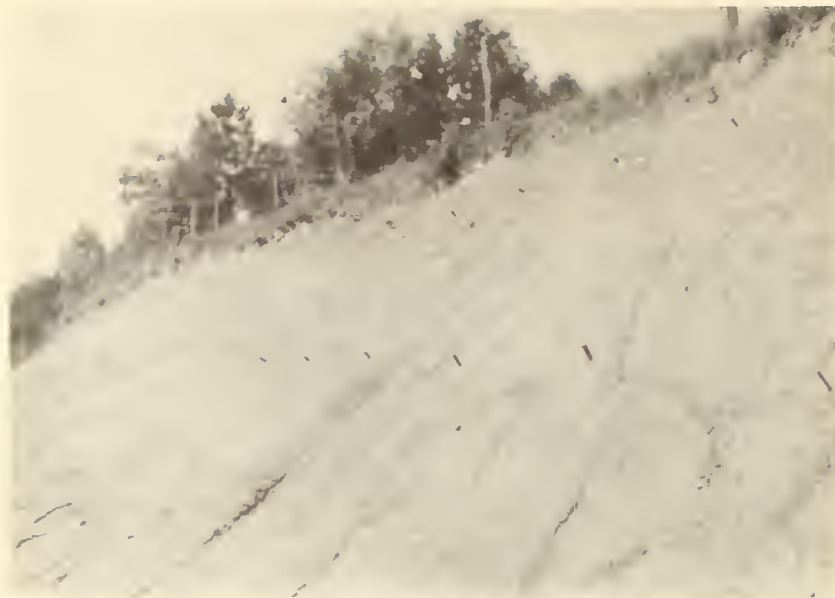
Figure 10.--A part of the two rows of metal pins driven into the bare bank until the tops were flush with the soil surface when the plots were established. After 2 years of erosion the pin tops are from 0.02 to 0.35 foot above the soil surface. The soil loosened by frost action has been washed from the upper part of the bank leaving it relatively firm.

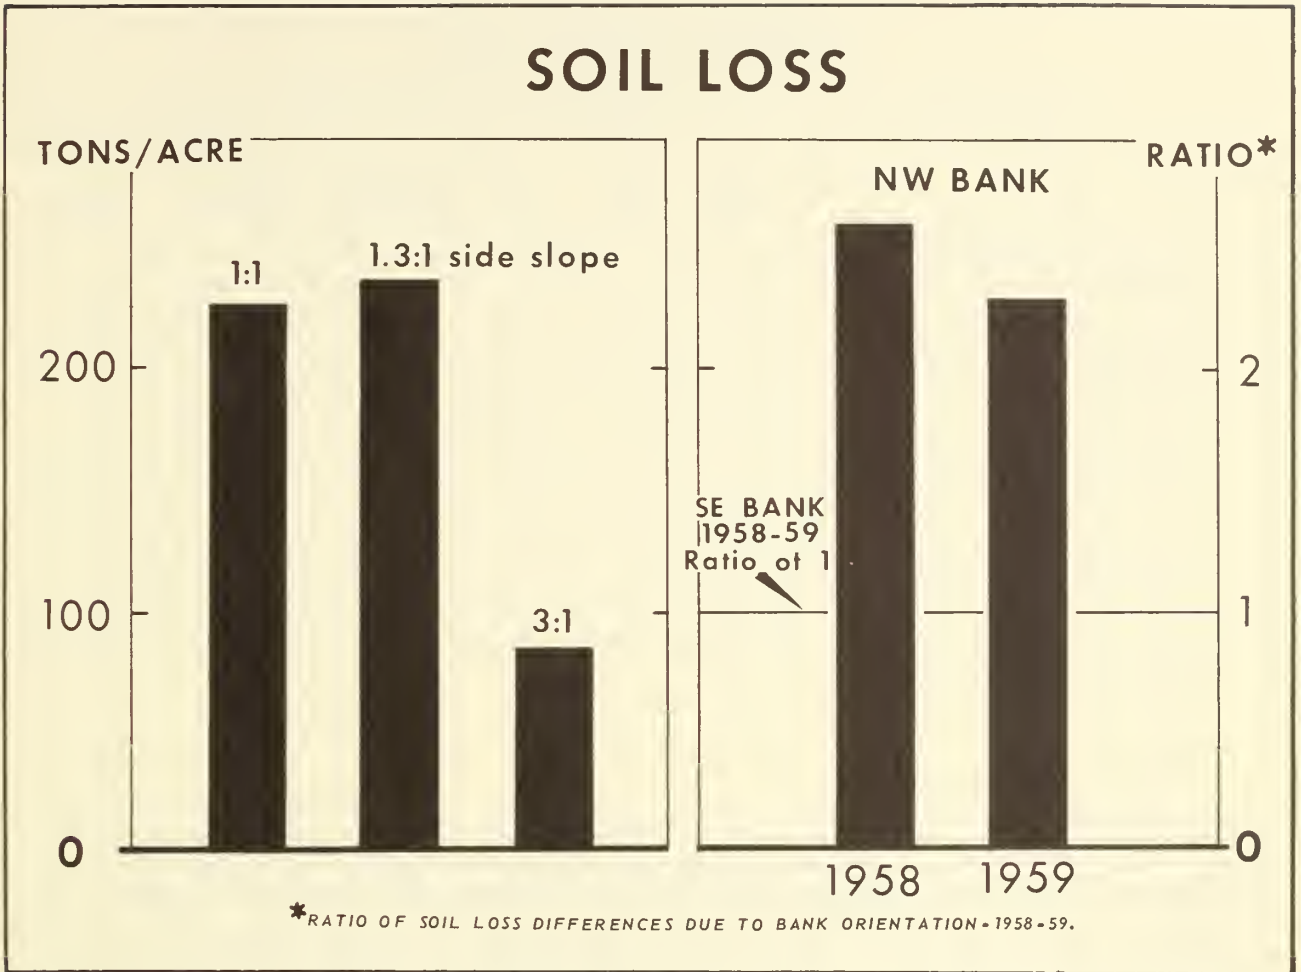
Figure 11.--Soil losses from different bore roodbank side slopes and the ratio of soil losses due to bank orientation, 1956, Corterville, Go.

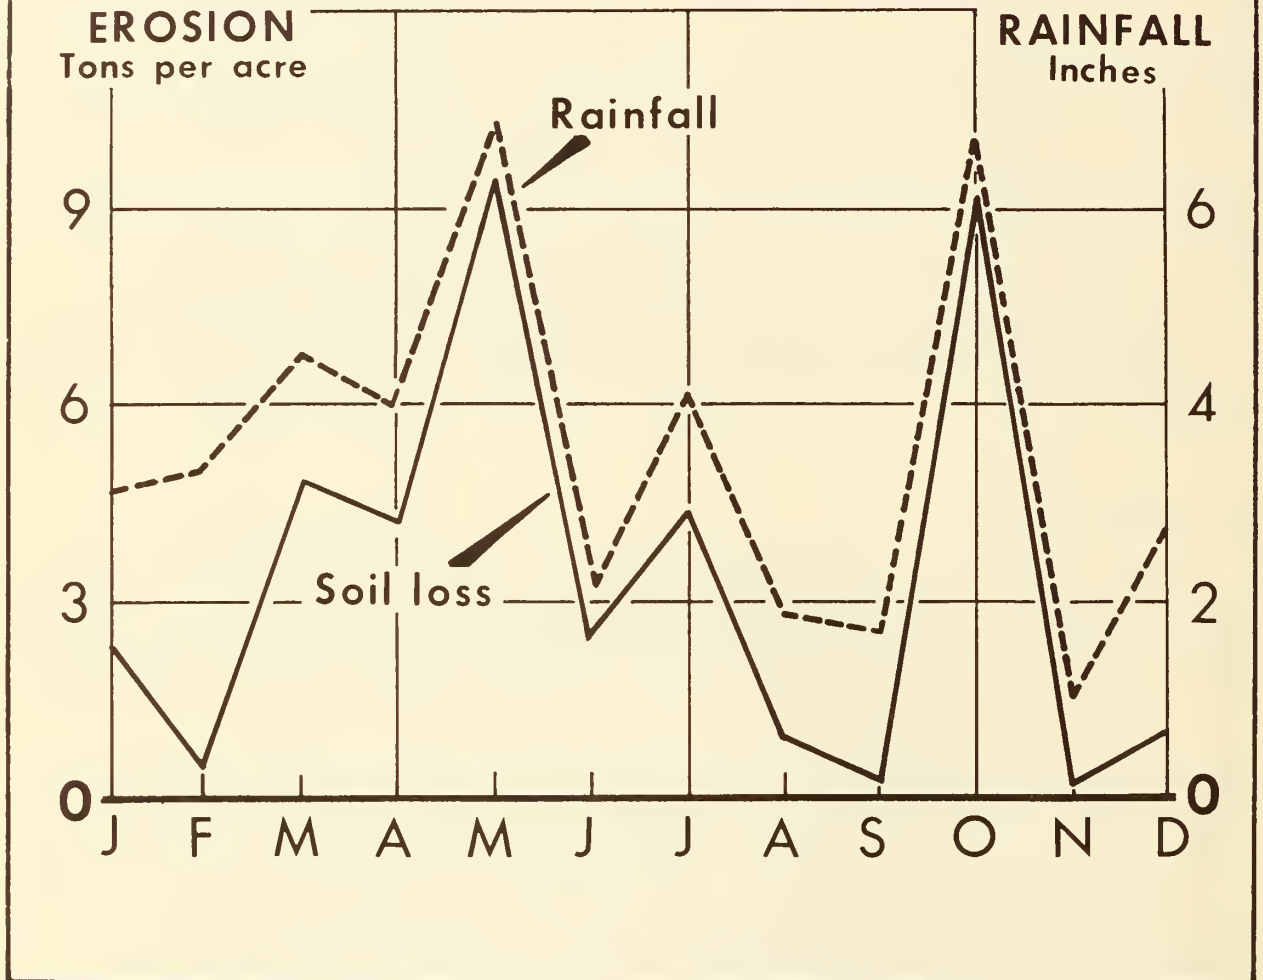
Figure 12.--Average monthly rainfall and soil movement from six plots as measured at channel outlets, in 1959, Cartersville, Ga.

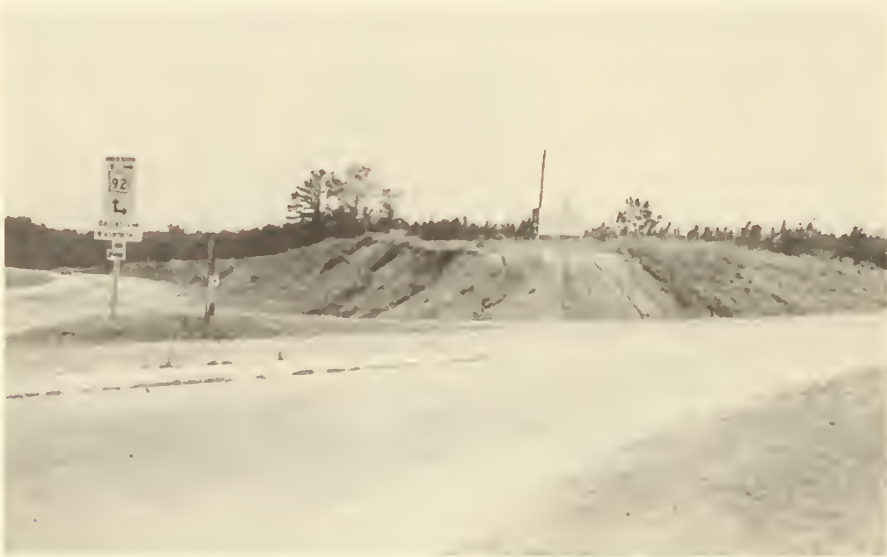
Figure 14.--A general view of a long bank on which 15 different species were planted November 1956 and April 1957. Crownvetch, seeded in 1956 in rye straw mulch grown in place, is shown on the right.

Crownvetch, a promising cool-season perennial legume, was propagated by seed and plants. It was planted from September to April, inclusive. Cover was quickly developed by seeding on a prepared seedbed in combination with 60 pounds of Abruzzi rye, or by mulching with crop straws after fertilizing and seeding. Fall transplantings at the base of steep banks were covered with frost-loosened material and often killed. Spring-set plants in the frost-loosened accumulations at the base of the banks survived better than fall-set plants. Full cover from partial stands developed by spreading from rhizomes. This cover remained green most of the year. The succulent top growth that developed after fall rains was frequently killed back by low temperatures in winter; however, growth was resumed in spring. Some strains of crownvetch produced heavy seed yields, whereas others produced few seed. All plantings were free from disease, although one planting was damaged badly by aphids in early spring of 1960. Little is known of the range of adaptation of crownvetch across the Southland. It is not used as a forage; therefore, its use has been limited in the Southeast (figs. 14 and 15).

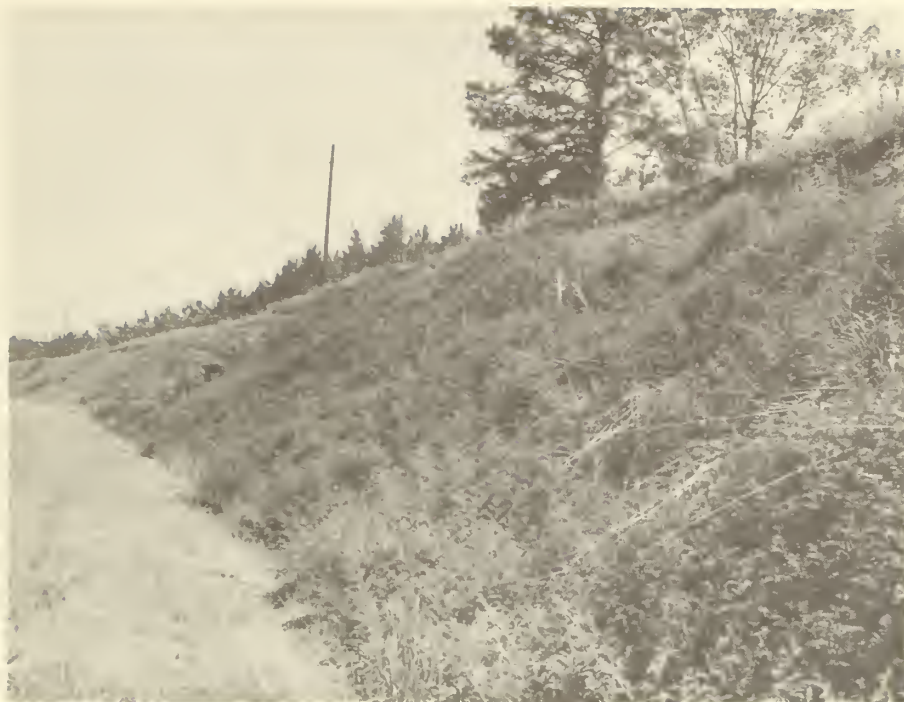
Figure 15.--Crownvetch plants were spaced 3 by 3 feet in November 1956. Full cover was obtained by late summer of 1958. Crownvetch has attractive foliage and is beautiful in full bloom.

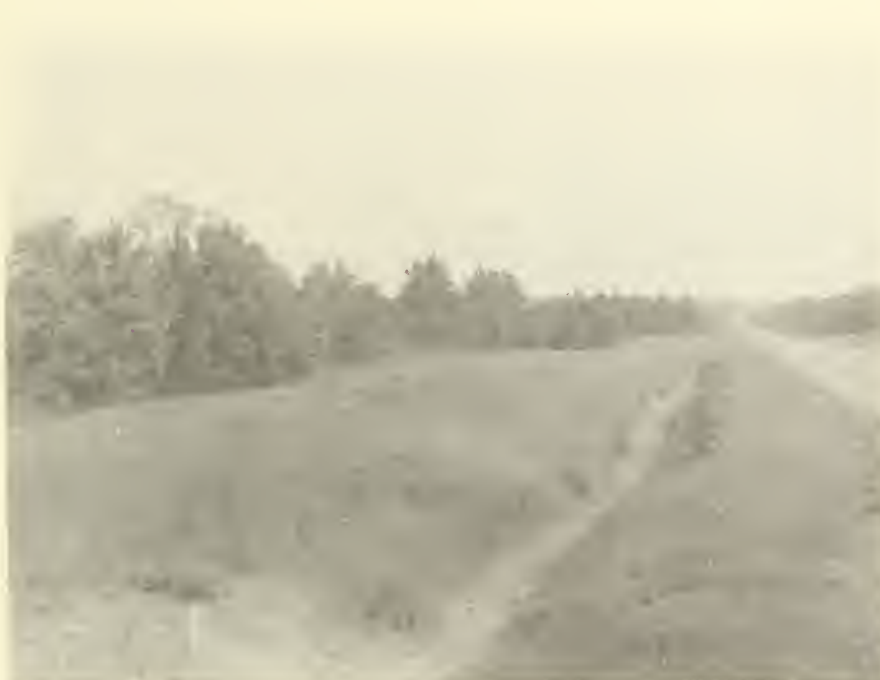
Figure 16.--General view of Coastal bermudagrass and weeping lovegrass growing on a low roadbank. Both plants provide good cover in full stand. Lovegrass is easy to establish, owing to its rapid germination with limited moisture.

Of the perennial warm-season grasses, best results were obtained from common bermudagrass and weeping lovegrass established from seed. Both species usually came up to good stands quickly and developed adequate cover within 4 to 6 weeks if they were planted from April 1 to June 15. Lovegrass germinated more quickly than bermuda, but it did not thicken as rapidly (fig. 16).

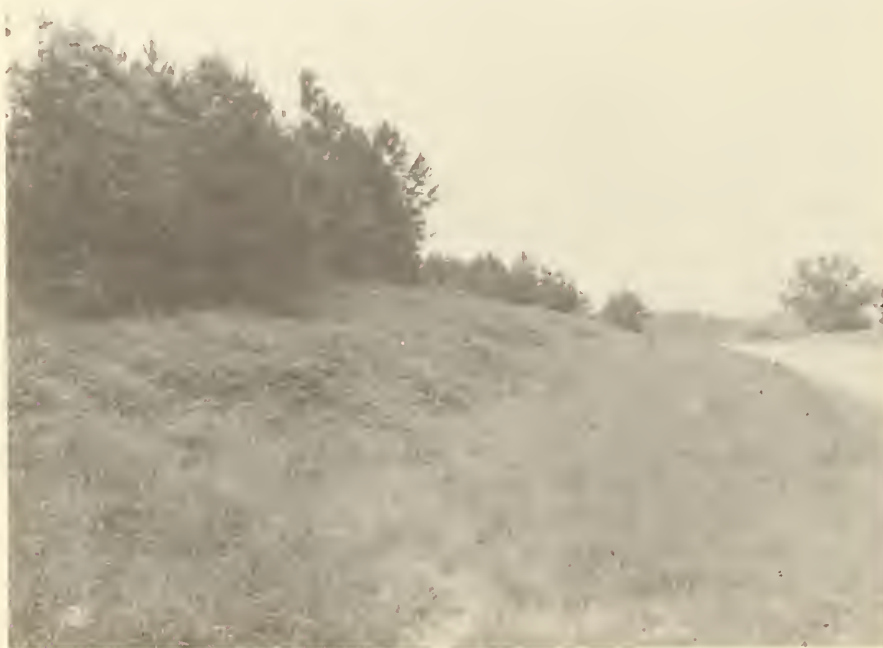
Figure 17.--A cover of honeysuckle that developed from natural stands is smothering out bahiagrass plantings on a roadbank of moderate slope. Honeysuckle, a vine plant, is useful on steep rough areas.

Honeysuckle adapted well to steep banks. When spaced 3 by 3 feet over an entire bank and fertilized properly, good cover was produced in 2 years. Where it was planted in staggered rows at the bottom of the bank, spaced not over 3 by 3 feet, it was useful for holding frost-loosened material on the bank. In about 4 years, with good survival and adequate fertilizer treatments, these plants covered the entire bank. Honeysuckle was useful adjacent to wooded areas where sunlight was limited and competition from trees was heavy. Honeysuckle stands, developed from wild plants or from seed dropped by birds, have encroached on a number of the grass plantings (fig. 17).

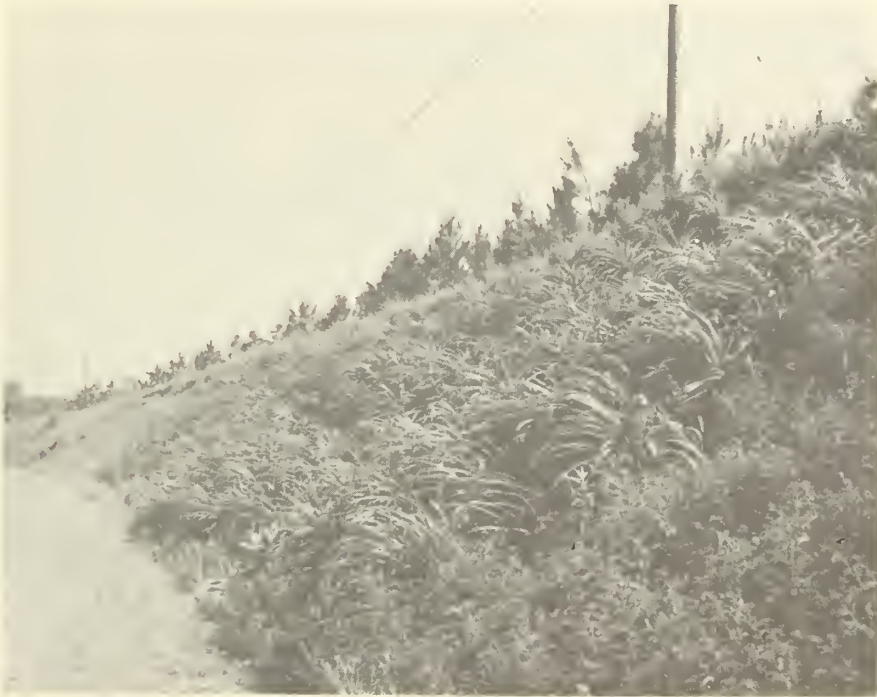
Figure 18.--Closeup of daylilies grown for erosion control and beautification of highway bank.

Ornamentals including daylilies, iris, vinca, and English ivy were used adjacent to home sites and public areas. Daylilies and iris planted from rhizomes, spaced 3 by 3 feet over the bank, usually gave good cover in 2 years. When fully developed and in bloom, daylilies and iris made a very showy bank for a period of 6 to 8 weeks during the blooming season (fig. 18).

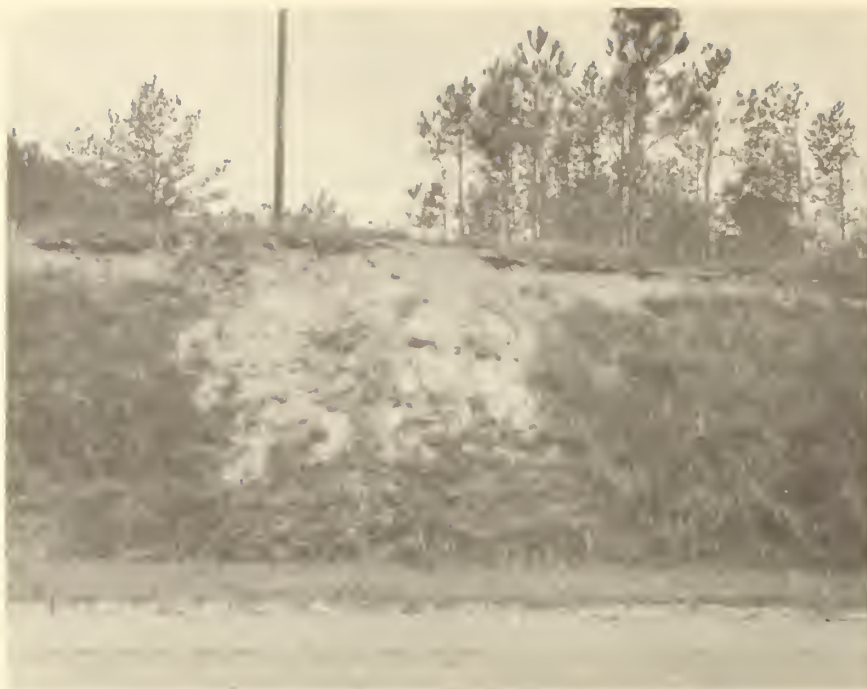
Figure 19.--Fertilizer stimulated natural stands of native poor-land types of wild plants to grow and provide good cover. Plot on right was fertilized with 1 ton of 4-12-12 and 2 tons of lime per acre in early March 1958. Maintenance fertilizer was 500 pounds of 4-12-12 plus 50 pounds of N per acre each year in 1959 and 1960. Plot to the left was fertilized with 250 pounds of 4-12-12 and 2 tons of lime per acre in early March 1958. Maintenance fertilizer consisted of 250 pounds of 4-12-12 and 50 pounds of N per acre in 1959 and 1960. No additional seeding was done. Although the plot on the right was fertilized at a different rate from the plot on the left, the covers developed on the plots were approximately the same. Plot in center received neither fertilizer nor lime.

Broomsedge, a native plant requiring little fertilizer, has proved successful on several roadbanks and has withstood the droughty conditions on southern exposures. Stands of this species were established by cutting the mature straw in old abandoned fields when seed were ripe in October and spreading it as a light mulch on unprepared and unfertilized banks. When seed began to germinate the following spring, fertilization preserved stands and an excellent cover developed. Although only a small amount is required, where fertilizer was omitted or delayed too long after germination, the weak plants failed because of starvation or were washed off the bank by summer rainstorms. On a number of old roadbanks, thin natural stands of broomsedge plants were fertilized to encourage growth and seed production. Cover developed by this method was effective, economical, and seemed to be rather permanent. Complete fertilizer (4-12-12) applied each year for 2 years at the rate of 500 pounds per acre and topdressed with 50 pounds of nitrogen per acre was adequate to develop good cover (figs. 19 and 20).

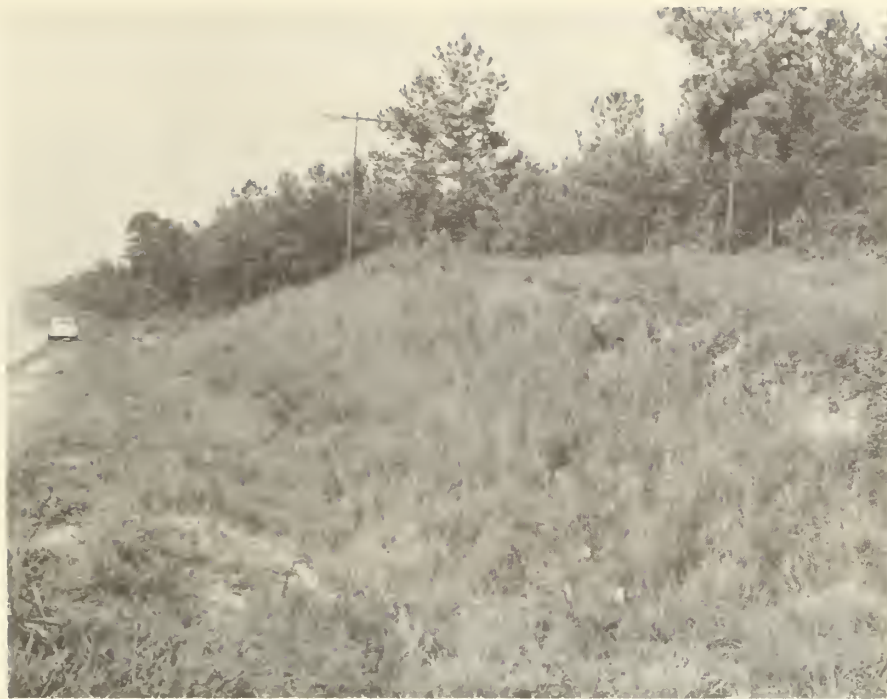
Figure 20.--Broomsedge straw, cut from adjacent field areas in October when full of mature seed, was lightly mulched on this roadbank. In May, after seeding and when stands were up, fertilization preserved the stand.

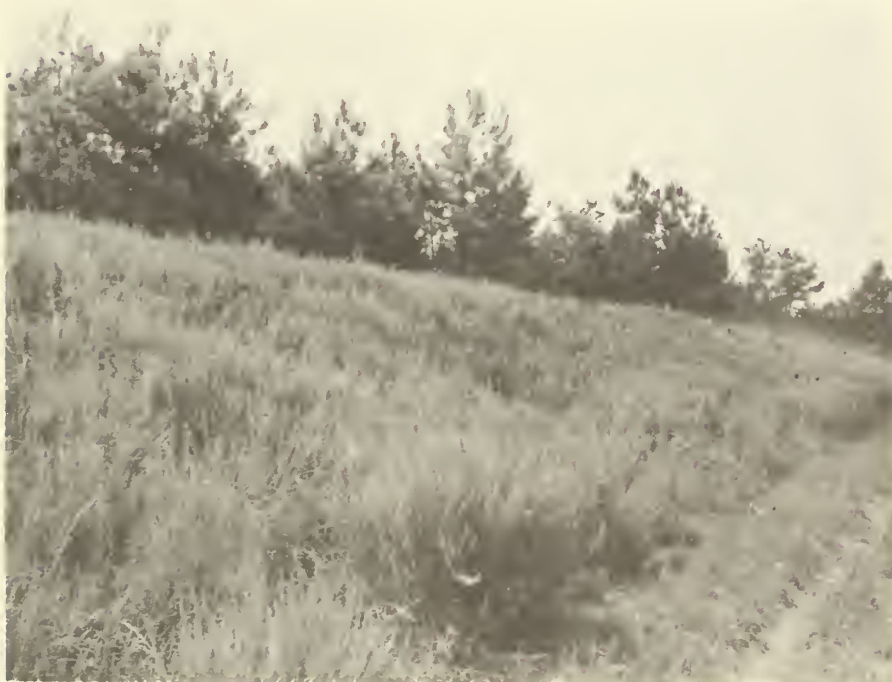
Figure 21.--Closeup of sericea used for erosion control on roadbank. Sericea, a deep-rooted perennial legume, provides excellent cover in full stand. This plant is adapted to most roadbank sites, but will not stand frequent late summer mowing.

Sericea lespedeza, a perennial legume, was used to a limited extent. It was established by direct seeding and by mulching with its seed-bearing straw. Both methods of establishment were successful. Sericea survived well on unfavorable sites adjacent to forest where light was reduced and competition from tree roots was heavy. It was injured badly by late summer mowing. Sericea will not survive long in wet soils, but is adapted to most well-drained roadbank sites. It is widely used on steep rocky banks where its extensive root system tends to hold soil in place (fig. 21).

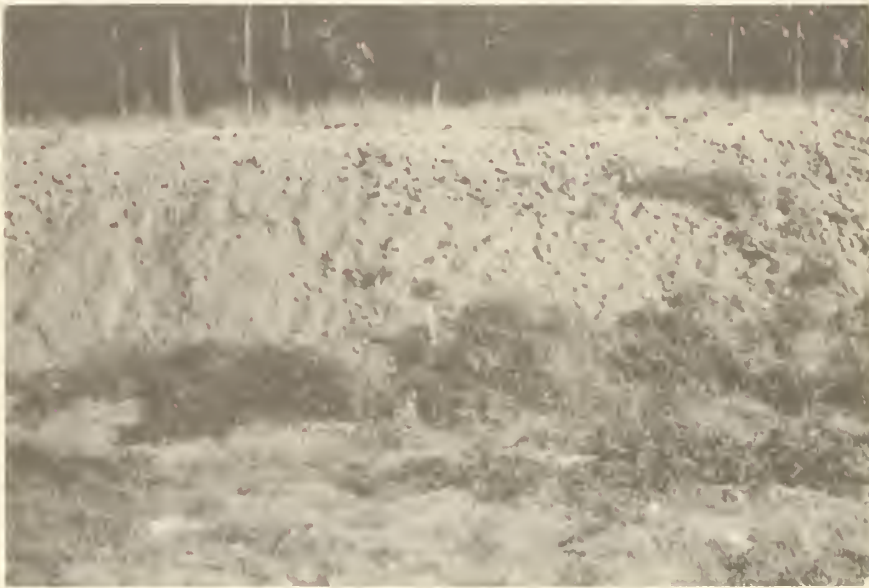
Figure 23.--This area was planted to crownvetch in October 1958. The area to the right of stakes was mulched with plastic sheets. The area to left of stakes was not mulched. Good stands developed over both plots, but plants were heaved out of the soil by frost action. Heavy summer rains destroyed stands developed from spring seeding where the bank was not mulched.

During the summer large amounts of rain falling at high intensity were very destructive to new seedlings of slowly developing species. The beating action of raindrops and runoff floated most of the fertilizer and many of the seed from the planted area. In extreme cases, plots were damaged by runoff from areas above some of the planted banks. Where fertilizer was lost, seedlings failed to develop until they were refertilized (figs. 22 and 23).

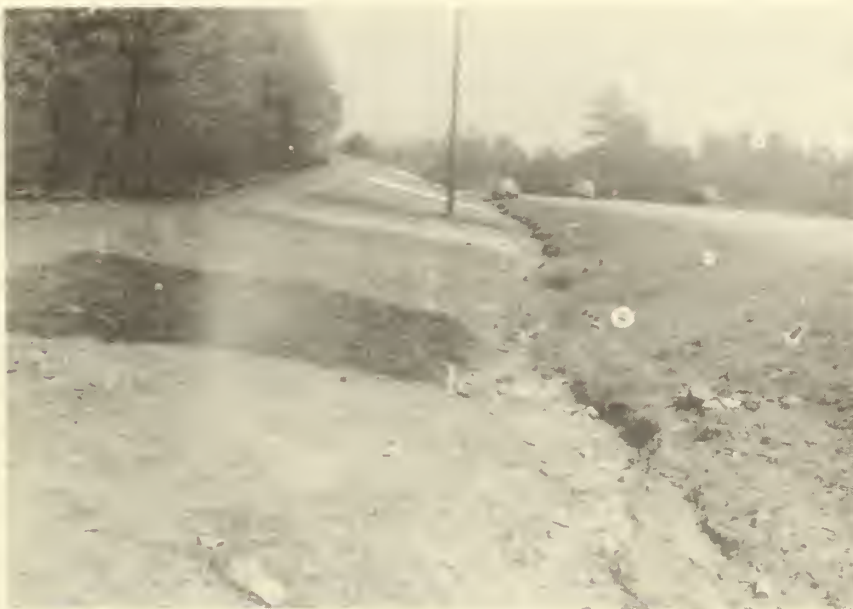
Figure 24.--A general view (in upper half of photograph) of roadside areas sown to common bermudagrass, with different plots mulched with pine straw, 2 and 4 tons per acre of grain straw, paper mesh, clear plastic and no mulch. Mulch was essential for anchoring seed and fertilizer on steep slopes and for protecting all slope conditions from heavy rainstorms. In general, the crop straws were more effective and easier to use.

Pine straw was exceptionally good material for mulching experimental plots. It was free of grass and weed seed, remained in place well, and protected the plots against weather hazards (figs. 24, 25).

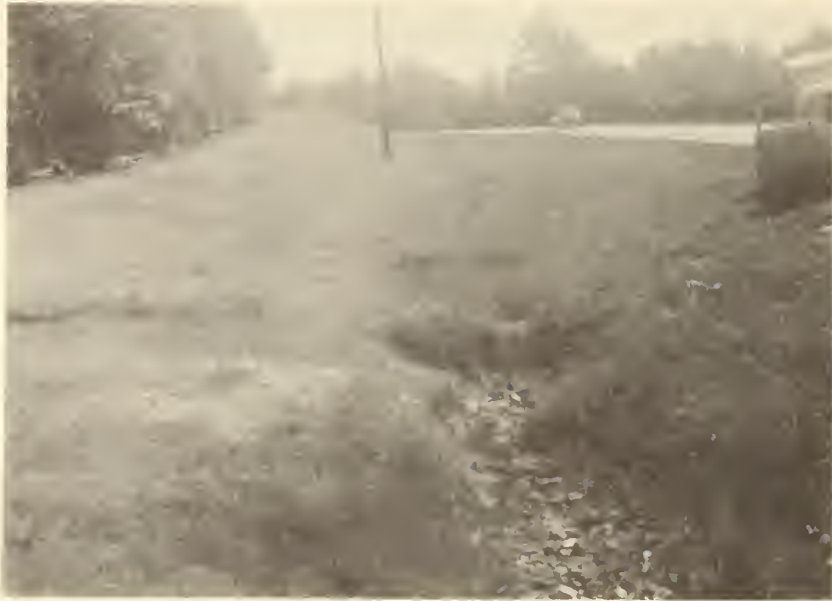
Figure 25.--The mature stand of bermudagrass resulting from the mulch treatments.

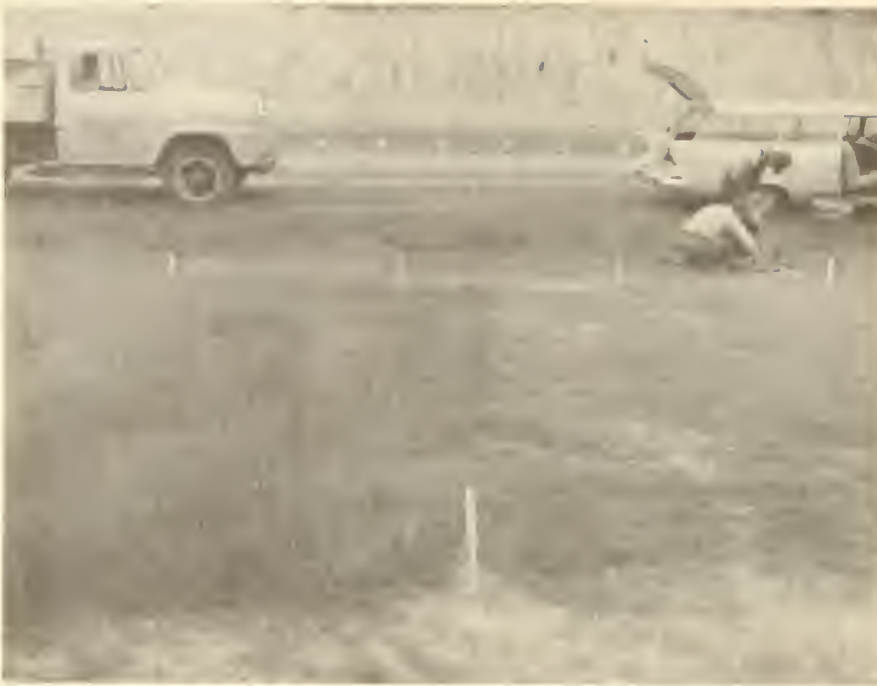
Figure 26.--In the nitrogen evaluation study, different rates of 8-24-8 containing water-soluble nitrogen were applied. Plot to the right was fertilized with 625 pounds of 8-24-8 per acre. No nitrogen was applied as a topdressing. Plot to the left was fertilized with 625 pounds of 8-24-8 and topdressed with 50 pounds of N derived from ammonium nitrate.

Topdressing of fertilizer applications were made at the rate of 50 pounds per acre at intervals, as needed, to produce adequate cover. Ammonium nitrate and urea gave the greatest increase in yield of bermudagrass hay. Ureaform and 10-20-10 fertilizer with slowly water-soluble nitrogen failed to hold the October yield up to the July level (fig. 26, table 11).
